Visual Termite Inspection & Report in Accordance with AS 3660.2-2000

1 McManus Street, Wilson, Western Australia, City of Canning, 6107, Australia

Visual Termite Inspection Report in accordance with AS 3660.2-2000

Client:	Mr Phil Tiang
Client Address:	
Re: Structure at:	1 McManus Street, Wilson, Western Australia, City of Canning, 6107, Australia
Phone:	0412004885
Fax:	
Mobile:	
Date of the Inspection:	27 Jun 2017
Invoice No:

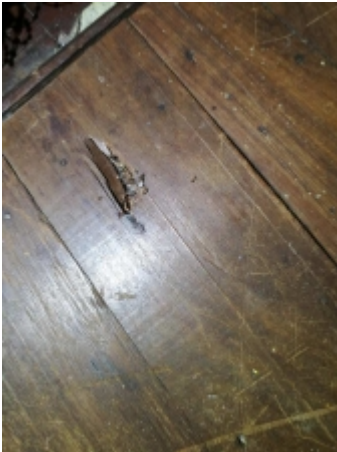
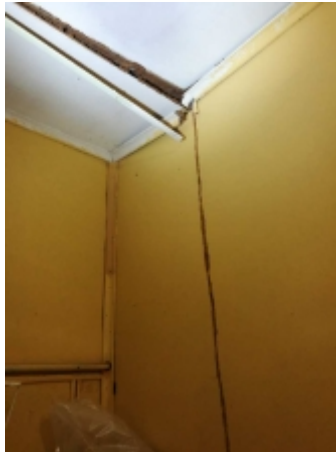
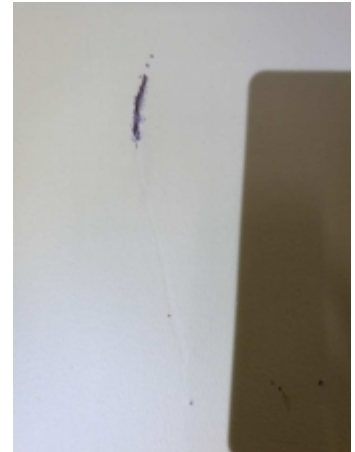
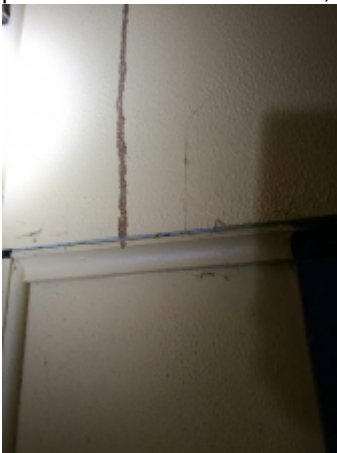
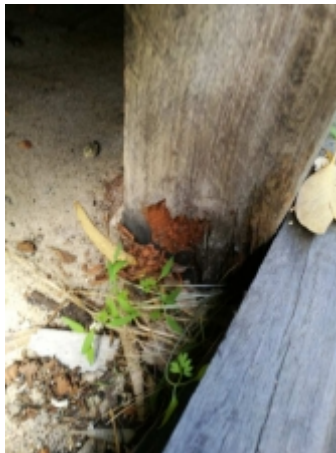
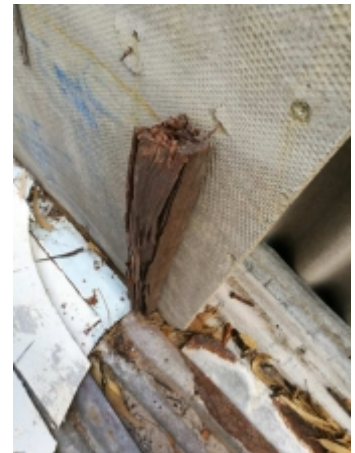
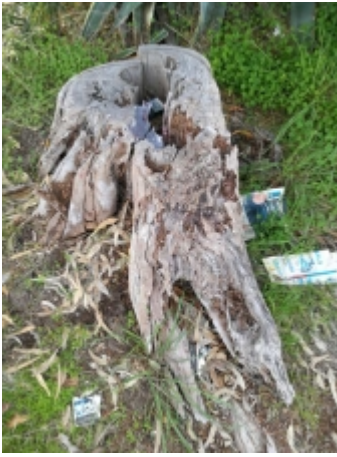
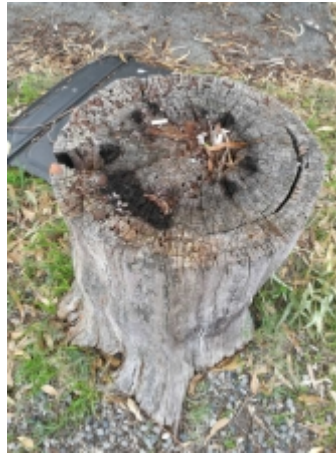
Termite Damage Photos

<p>Termite workings and/or damage were found mainly in but not limited to:</p>	<p>See photo comments, Stump near letterbox, Timber piers subfloor, Laundry area, Internal areas, Loose timber to yards and garden sleepers , Internal floorboards near laundry, Stump front yard</p>
---	---

<p>Whilst we are not builders, the termite damage appears to be:</p>	<p>Moderate to Extensive</p>
---	-------------------------------------

Stumps near letterbox, Laundry walls and above roof, timber floorboards near laundry ,wall to living area above air conditioner, wall other side of bathroom, timber pier subfloor near bathroom, loose timber lhs of house

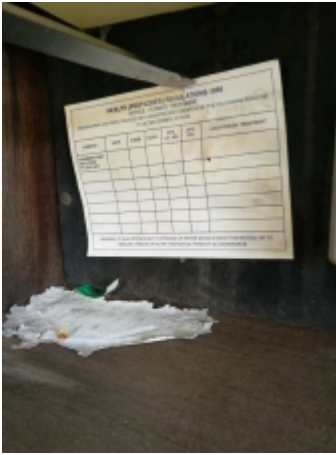
Durable Sign Photos

If located, the sign was found in In the meter box. This indicates a chemical treated zone has been installed. This firm can give no assurances with regard to work that may have been previously performed by other firms.

Chambers barrier 2015

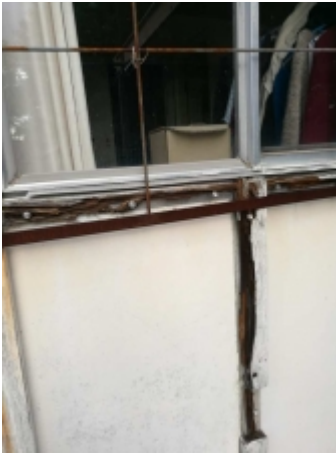
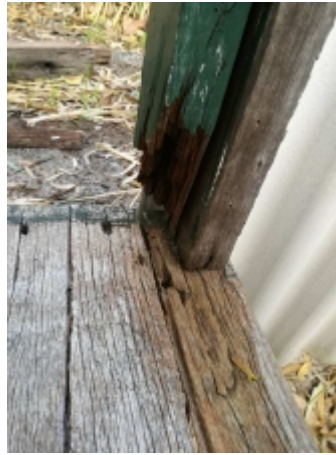
Timber Decay Photos

Wood rot: At the time of the inspection was visible evidence of wood decay fungi (rot) found?	Yes
Evidence was found in	Timber beams on wall to external of house , Front porth, Front porch

Wood decay fungi are conducive to subterranean termites. You should consult a builder or other building expert to find out what must be carried out to prevent further decay (repairing of drainage, leaks and/or sealing the timber) and to repair the damage.
