Visual Termite Inspection & Report in Accordance with AS 3660.2-2000

1 McManus Street, Wilson, Western Australia, City of Canning, 6107, Australia

Visual Termite Inspection Report in accordance with AS 3660.2-2000

Client:	
Client Address:	
Re: Structure at:	1 McManus Street, Wilson, Western Australia, City of Canning, 6107, Australia
Phone:	
Fax:	
Mobile:	
Date of the Inspection:	27 Jun 2017
Invoice No:

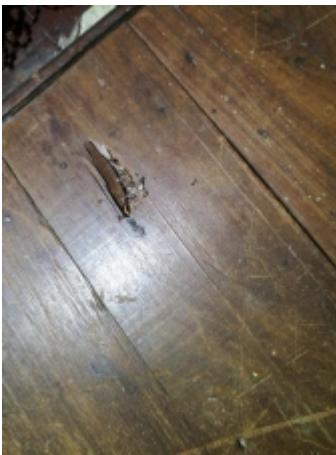
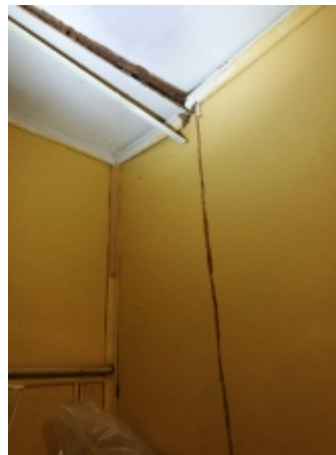
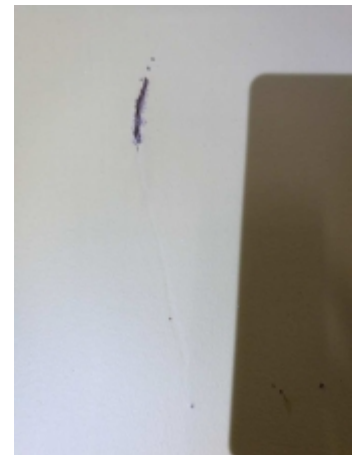
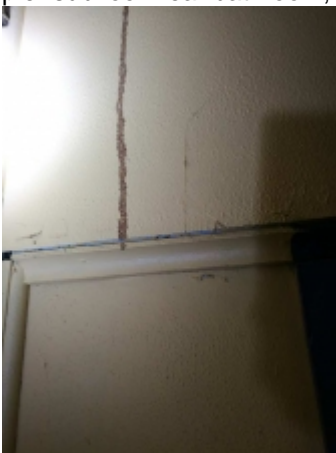
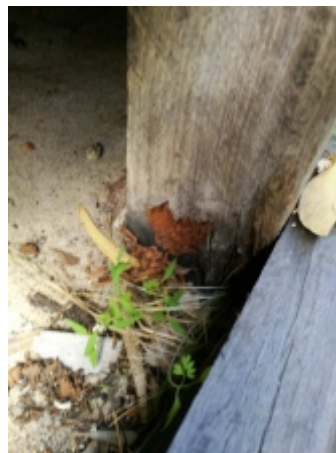
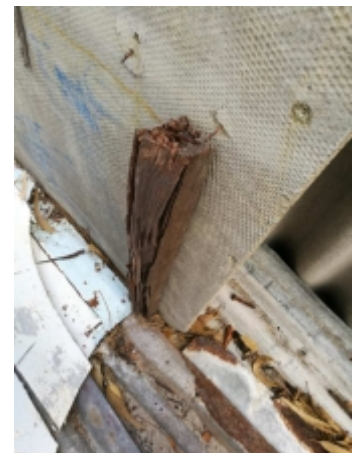
Termite Damage Photos

See photo comments, Stump near letterbox, Timber piers subfloor, Laundry area, Internal areas, Loose timber to yards and garden sleepers, Internal floorboards near laundry, Stump front yard

Moderate to Extensive

Stumps near letterbox, Laundry walls and above roof, timber floorboards near laundry, wall to living area above air conditioner, wall other side of bathroom, timber pier subfloor near bathroom, loose timber lhs of house
